HO-7

## Union Chapel (St. Andrew's Episcopal Church)

### **Architectural Survey File**

Union Chapel

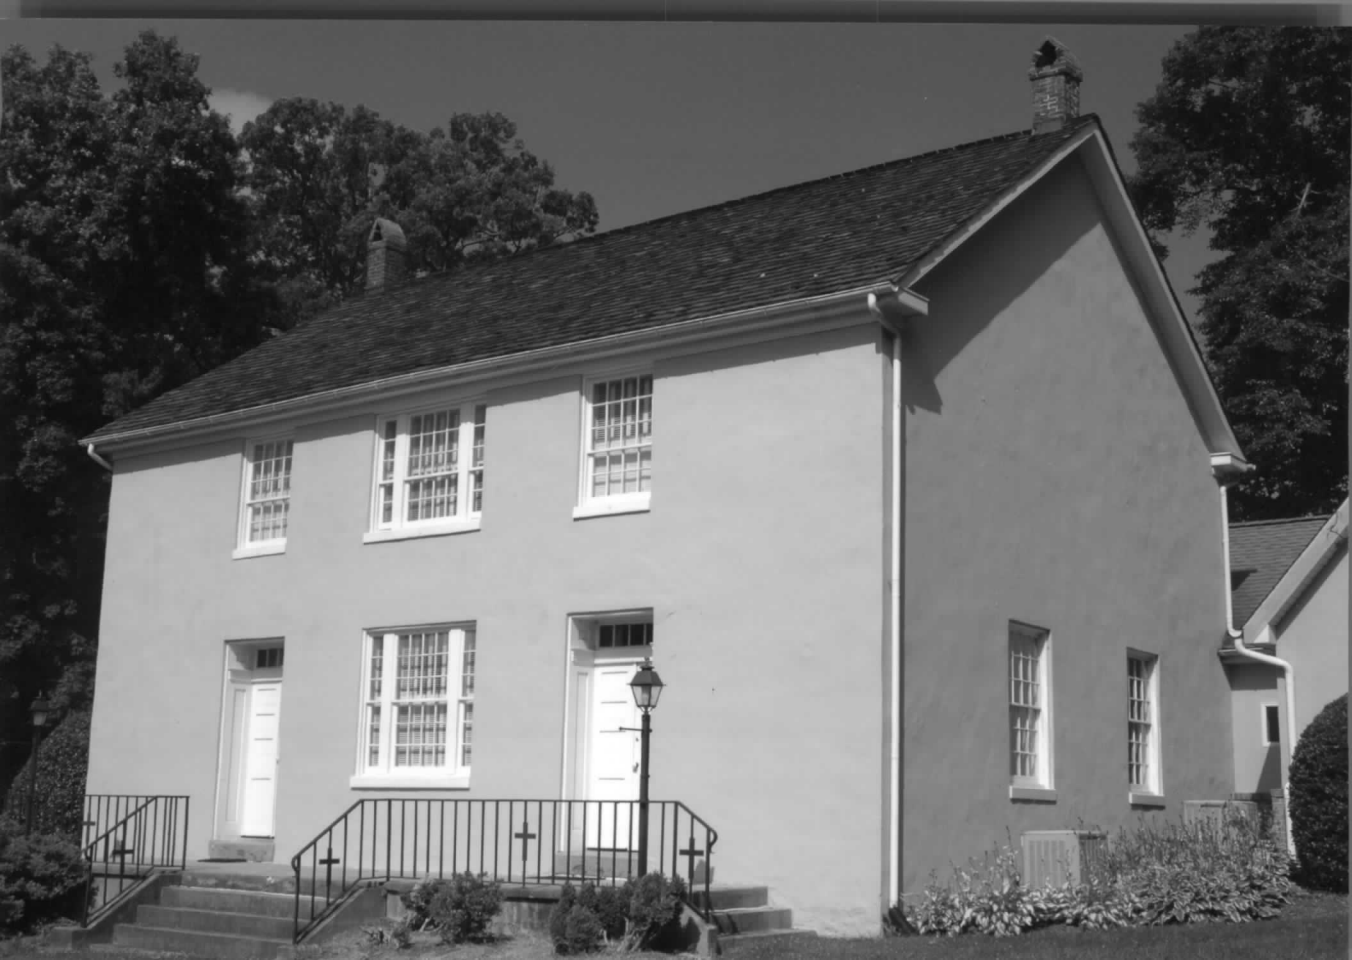
1 of 8

East + north elevations

The east elevation has two stories, or tiers, of openings. The lower tier, in the south bay, has double doors with four panels on each, and the panels have sunken fields and no panel moulds. There is one panel on each jamb, and it matches the doors. The transom bar has a triple broken field with a bead at the bottom and a Greek ovolo at the top. There is a five-light transom and one panel on the soffit and on each transom jamb, and they also match the doors. The door frame has a bullnose. There is a granite sill. The center bay has a tripartite sash with a twelve-over-twelve in the center and a three-over-three to each side. It has a wood sill and a bullnose frame. The north bay has a doorway that is identical to the south bay. The upper tier center bay matches the first story, while the north and south bays have a twelve-over-twelve sash with a wood sill and a bullnose frame.

The north elevation has two typical twelve-over-twelve sash on the lower tier and no openings in the upper tier of the gable end. The south elevation is identical to the north. On the west elevation the center bay projects, creating a chancel, and the roof continues at the same pitch over this projection. This projection contains a tripartite window with stained glass. The south side of the chancel has stained glass in a rectangular opening. The north side is identical, but is now within the addition. The south bay has double doors with three panels each, with sunken fields and no panel moulds. There is a granite sill and bullnose frame. The north bay is now within the addition, but is identical to the south bay except that the sill is now covered by new tile.

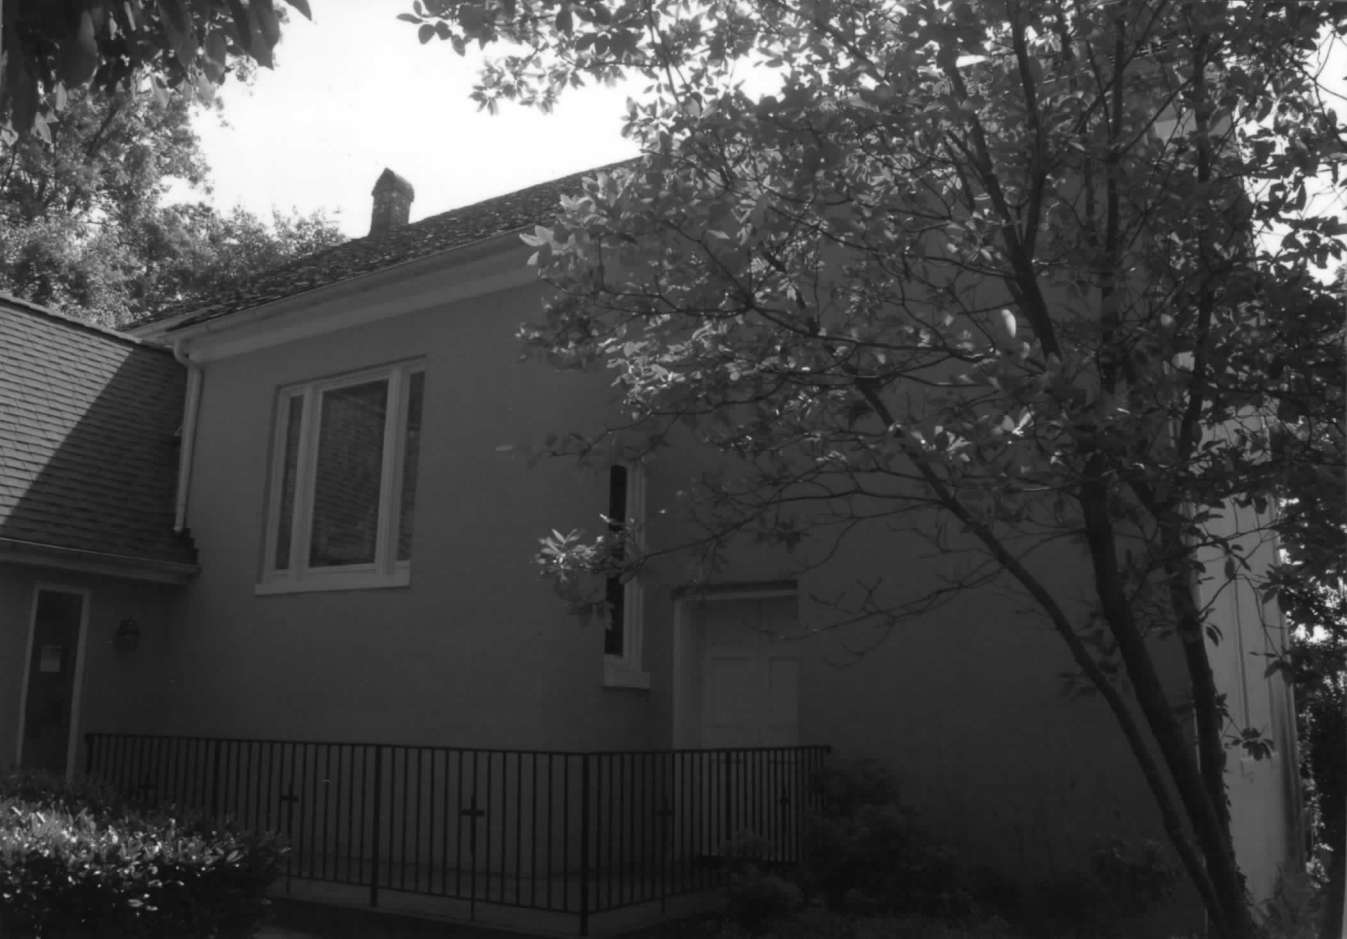
2 of 8

West & south elevations

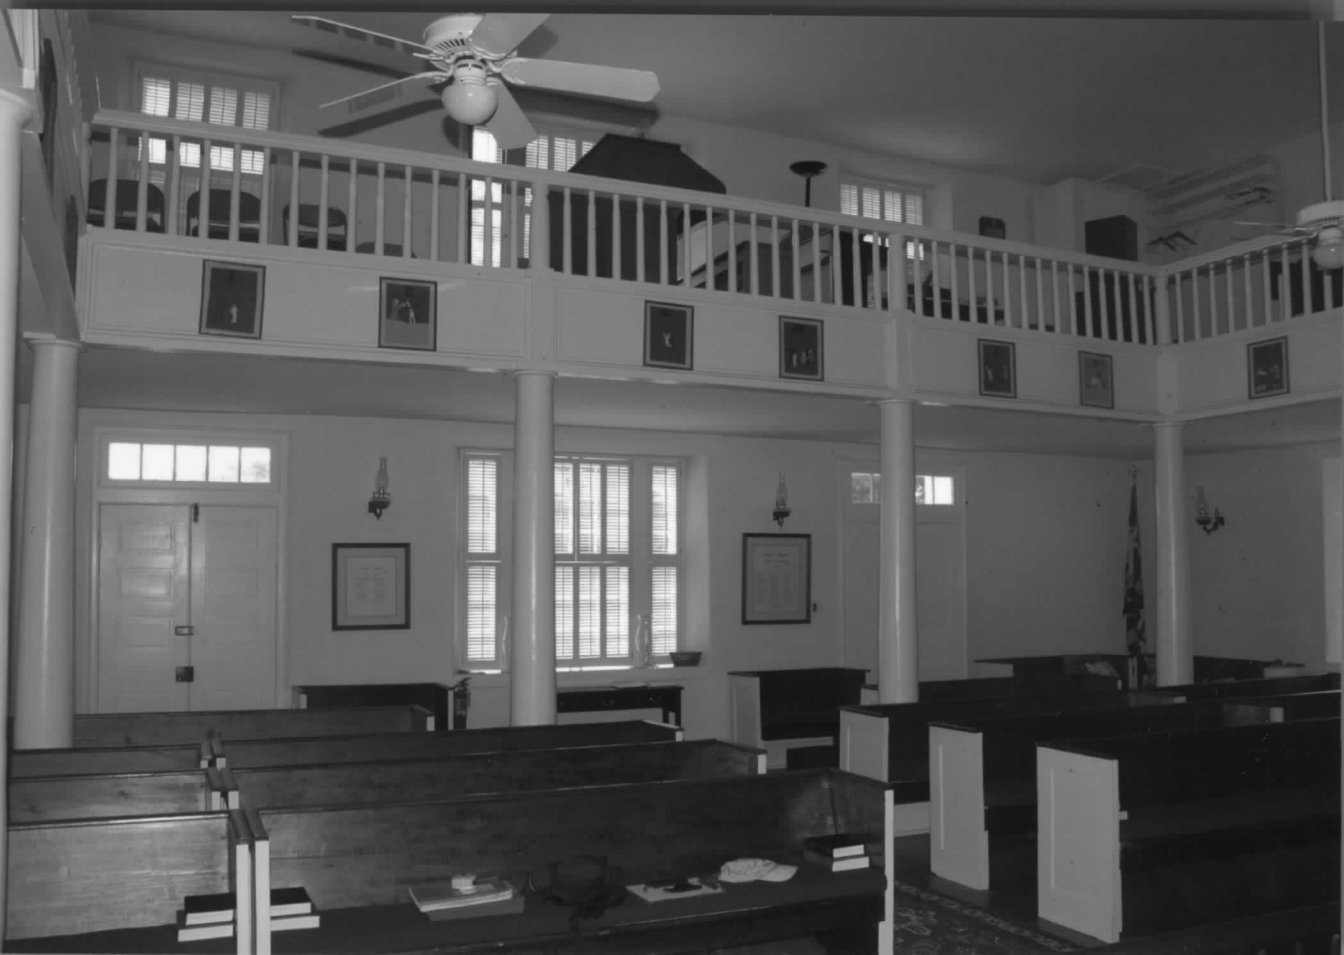
3 of 8

Interior, view Southeast

The interior is one open space laid out in a meetinghouse plan with a gallery on the north, east, and south sides that is supported on columns, and a chancel on the west. The flooring is new 3 1/4-inch pine and the baseboard appears to all be new, as well. The windows have splayed jambs and no architrave, and the sash have ovolo muntins, 8-inch by 10-inch lights, and no parting beads. They are mortised and tenoned and pinned. The walls are plaster on masonry. On the north, east, and south walls are cast iron brackets with glass oil lamps that are now electrified. The ceiling is plaster on expanded metal lath. The door architrave has a cavetto on the outer edge that appears to be added, with a Greek ogee backband that also appears to be added, and a beaded interior edge that appears to be original. The doors are mortised and tenoned and pinned and have no panel moulds on the interior side, either. They have plain cast iron rim locks with porcelain knobs and cast iron butts labeled "THO<sup>S</sup> CLARK". The transom is mortised and tenoned and pinned. The wood columns of the gallery are one solid piece, with a boxed plinth and a cavetto mould at the top. The two center eastern columns are cut out at the bottom, on an angle that is the same as the angle on the pew backs, for two pews to have been pushed back into the cut. The pews appear to be original, but have been cut down in length, and two pews have a triangular ghost in the center of the back where there is little oxidation of the wood; this marks the spot that was set into the cut on the columns. The pews are loose and are now arranged in three columns.

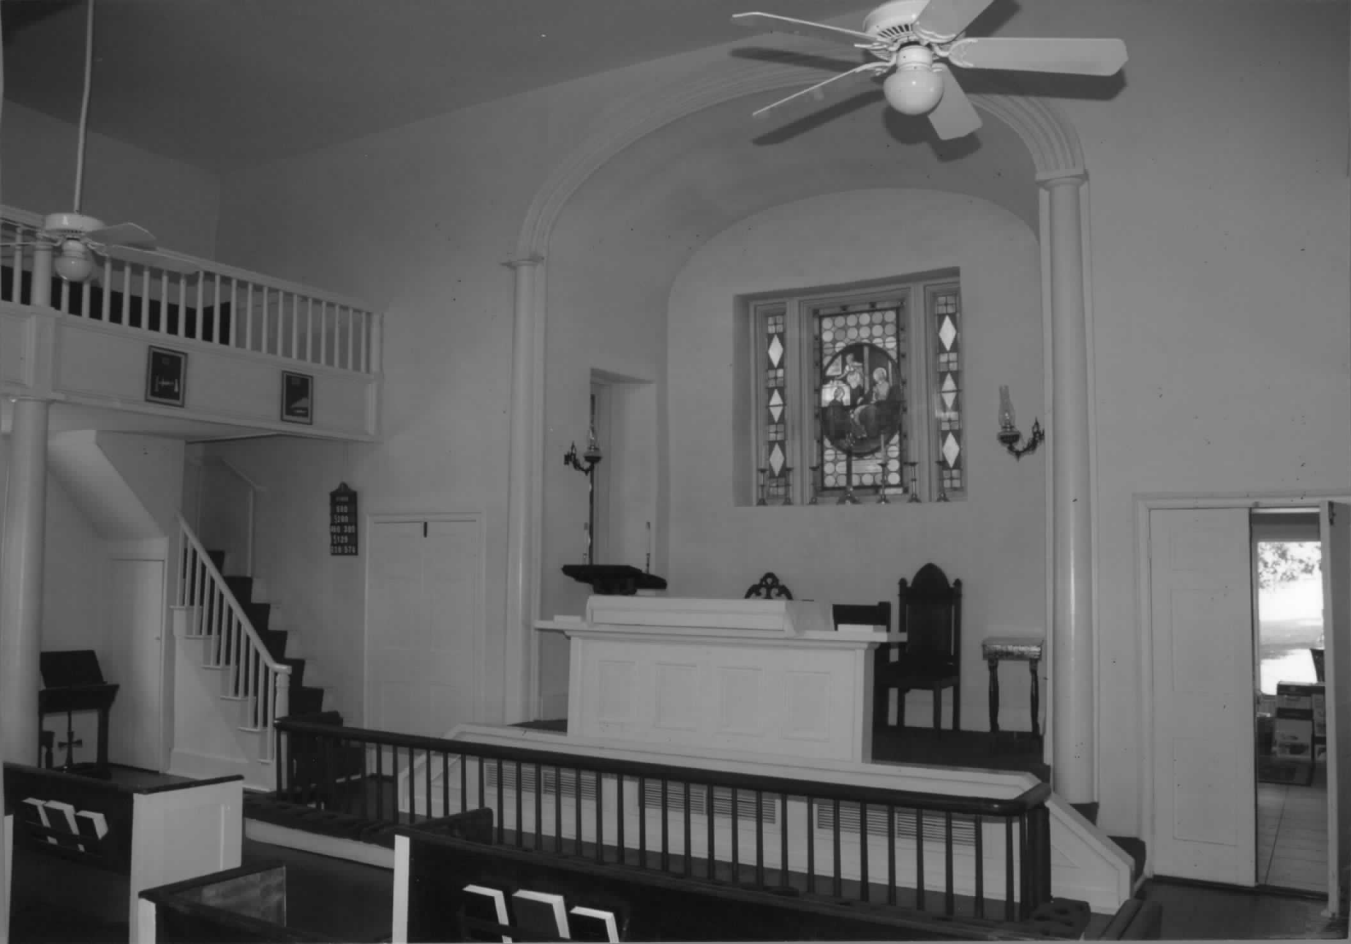
4 of 8

Interior, view southwest

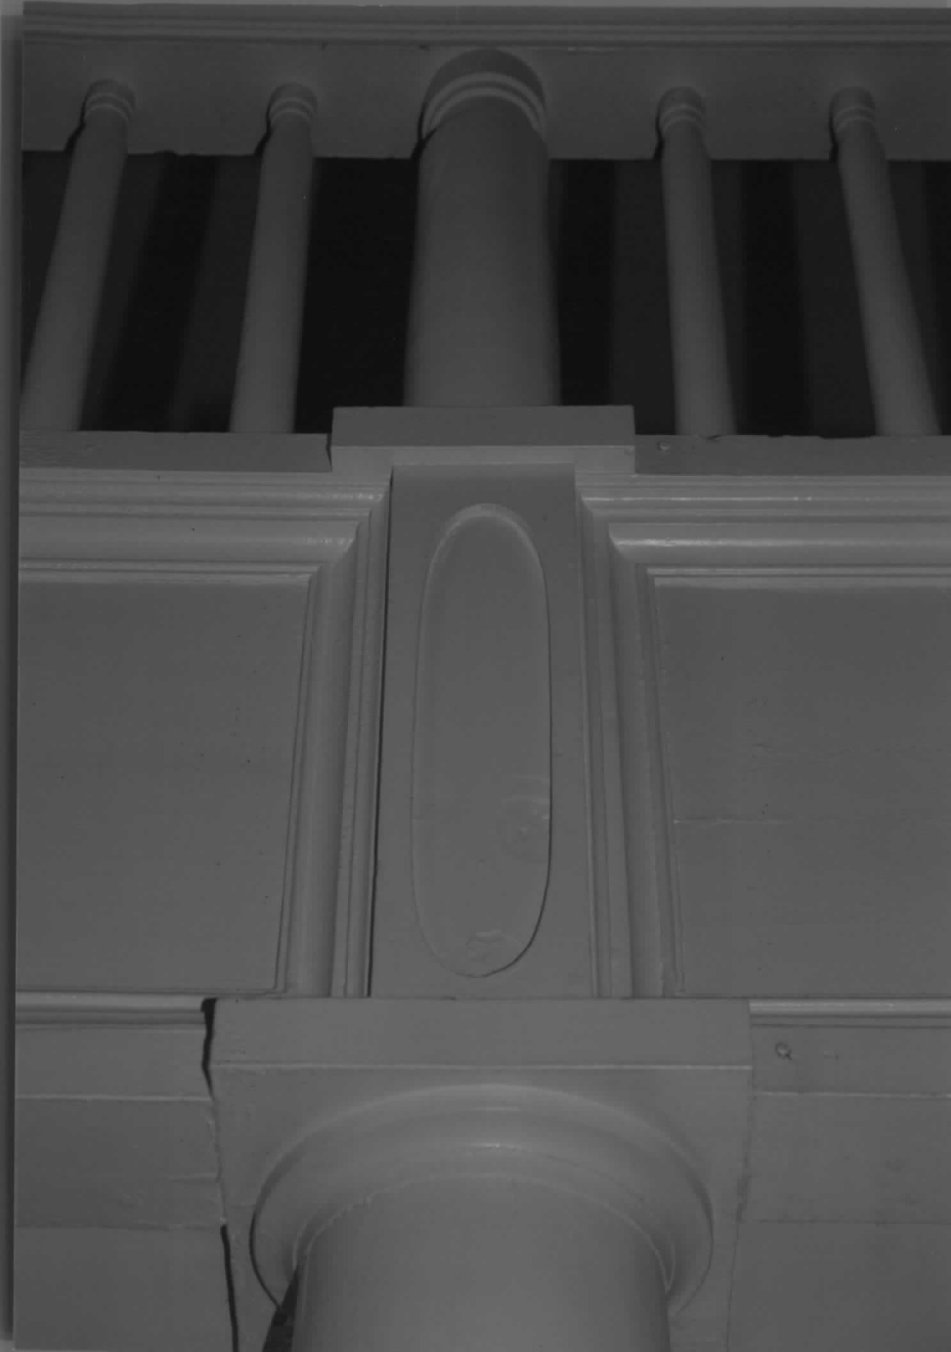
5 of 8

Interior, gallery railing detail

The gallery railing has imposts with oval panels above the columns, and flat sunken panels between that have a cavetto and bead mould. Above the imposts are newels with a slight taper, and the top is cut back in a series of fillets. There are round balusters that are similarly cut back at the top, and a flat railing. There are winder stairs in the northwest and southwest corners. The northwest stair is completely rebuilt, and there is no evidence of any earlier stair here. The southwest stair is built with cut nails and has modern reinforcement added. The newel is turned and slightly tapered, and cut back in a series of fillets at the top. There is a plain open stringer with square balusters and a  $\frac{3}{4}$  round handrail. There is a bead board door on plain cast iron butt hinges. The gallery has a flat floor to the interior, and is built up by one step on the rear  $\frac{2}{3}$ rds. There is one pew in place on the north and south sides, and it sits on this step. There is a hatch to the attic in the southeast corner.

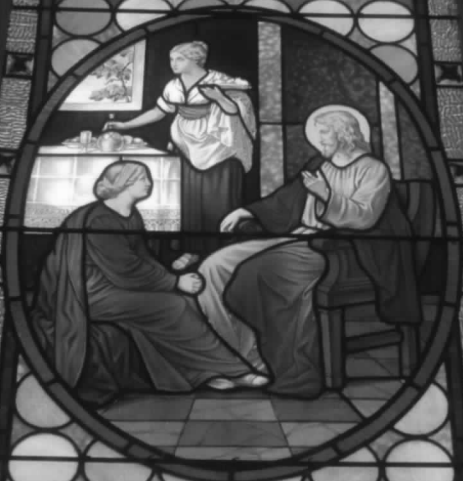
6 of 8

\* IN MEMORY OF \*  
\* JAMES B. MATHEWS \* 1887 \*  
\* AND \*  
\* KETTY G. MATHEWS \* 1884 \*

Interior, chancel window

The chancel opening in the west wall has a three-radius segmental arch with engaged half-columns on each side that sit on the step, with no plinth. The arch architrave appears to have a quirked Greek ogee on top, two lancet mouldings in the center, and a quirked Greek ogee and bead on the bottom. The jambs of the chancel are splayed. The west wall has old glass, while the sides have a geometric pattern. The center window contains figural glass of Christ with Martha and Mary. It shows Christ sitting in a chair, with a woman sitting before Him, a table in the background, and a woman holding a tray standing next to the table. The inscription below the window reads: "In Memory of James B. Mathews 1887 and Kitty G. Mathews 1884." The window is not signed.

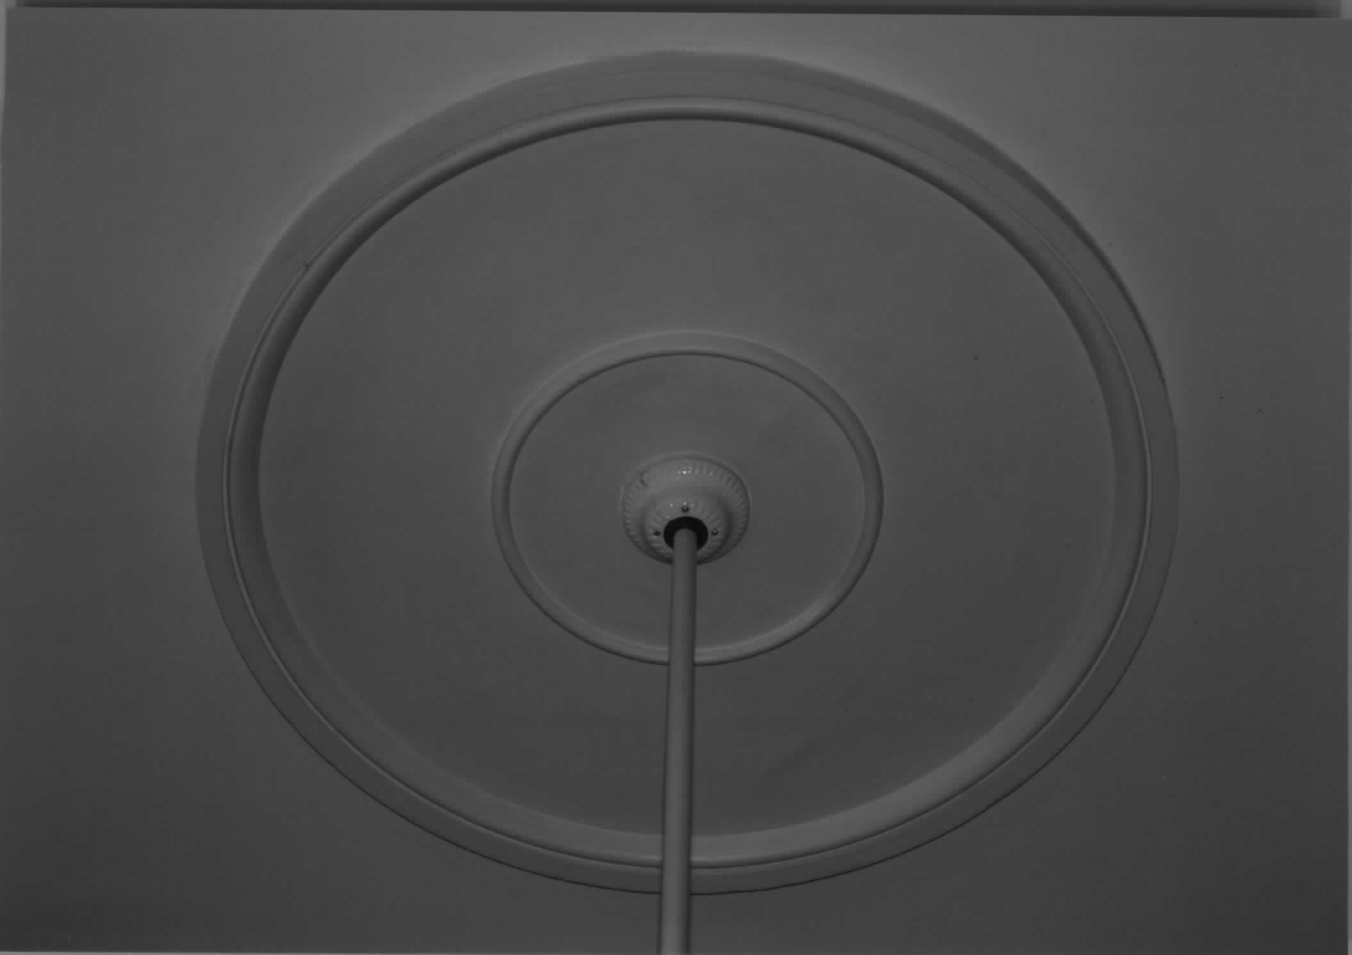
7 of 8

Interior, ceiling medallion

There are two run plaster ceiling medallions, and they have a large bead on the inner ring and a fillet and quirked Greek ovolo on the outer ring. The pulpit sits at the west side of the sanctuary, between the pews and the chancel. It is on a raised dais that has a paneled front. Three panels have been cut out for vents, but the remaining panels are sunken and flat and have a half-round panel mould with a fillet inside of it. There are three steps at the north and south ends of the dais. The pulpit front has four panels that match the dais front, with a railing on top that has an ogee bed mould. There is a new lectern shelf on top of the railing. The back side of the pulpit is sash-sawn, and the rails and stiles are mortised and tenoned and pinned. The beveled panel backs are hand-planed. There is an altar rail in front of the pulpit, on three sides, with rounded corners. It has a natural varnished finish and newels at either end that have the top cut back in a series of fillets like the newels on the gallery (see below). The balusters are round. The railing appears to have been rebuilt with some old pieces.

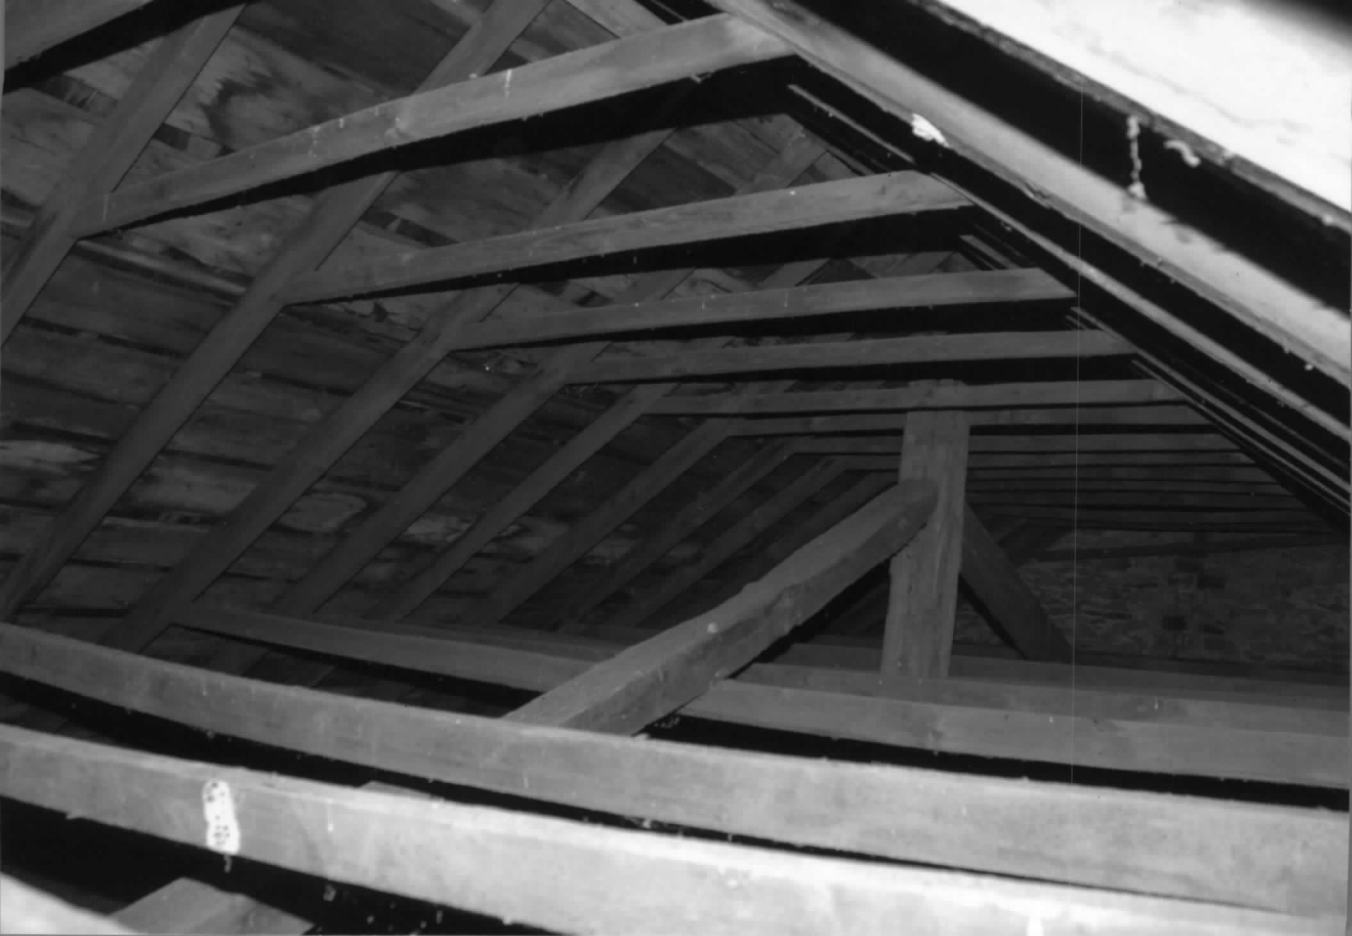
8 of 8

Attic framing, view northwest

The attic framing has a hewn summer beam 11 inches square that runs north-south, with a post on top of it, in the center, which is pegged into the beam. There is a strut on each side of the post that is 6 inches square and hewn, and runs from near the top of the post down to the summer where it meets the wall. There are log joists running from the top of the east and west walls to the summer. They are hewn square near the summer, with a tenon into the summer. The rafters have a birds-mouth cut at the foot and are set on a false plate, but aligned with the joists. They are sash-sawn and have an open-faced bridle and peg at the ridge. There are two sets of collar beams for each rafter couple, and they are half-lapped and nailed with cut nails. Both the north and south walls have bricks set rowlock and toothed into the stone wall in the center to create a chimney flue in the thickness of the stone wall.

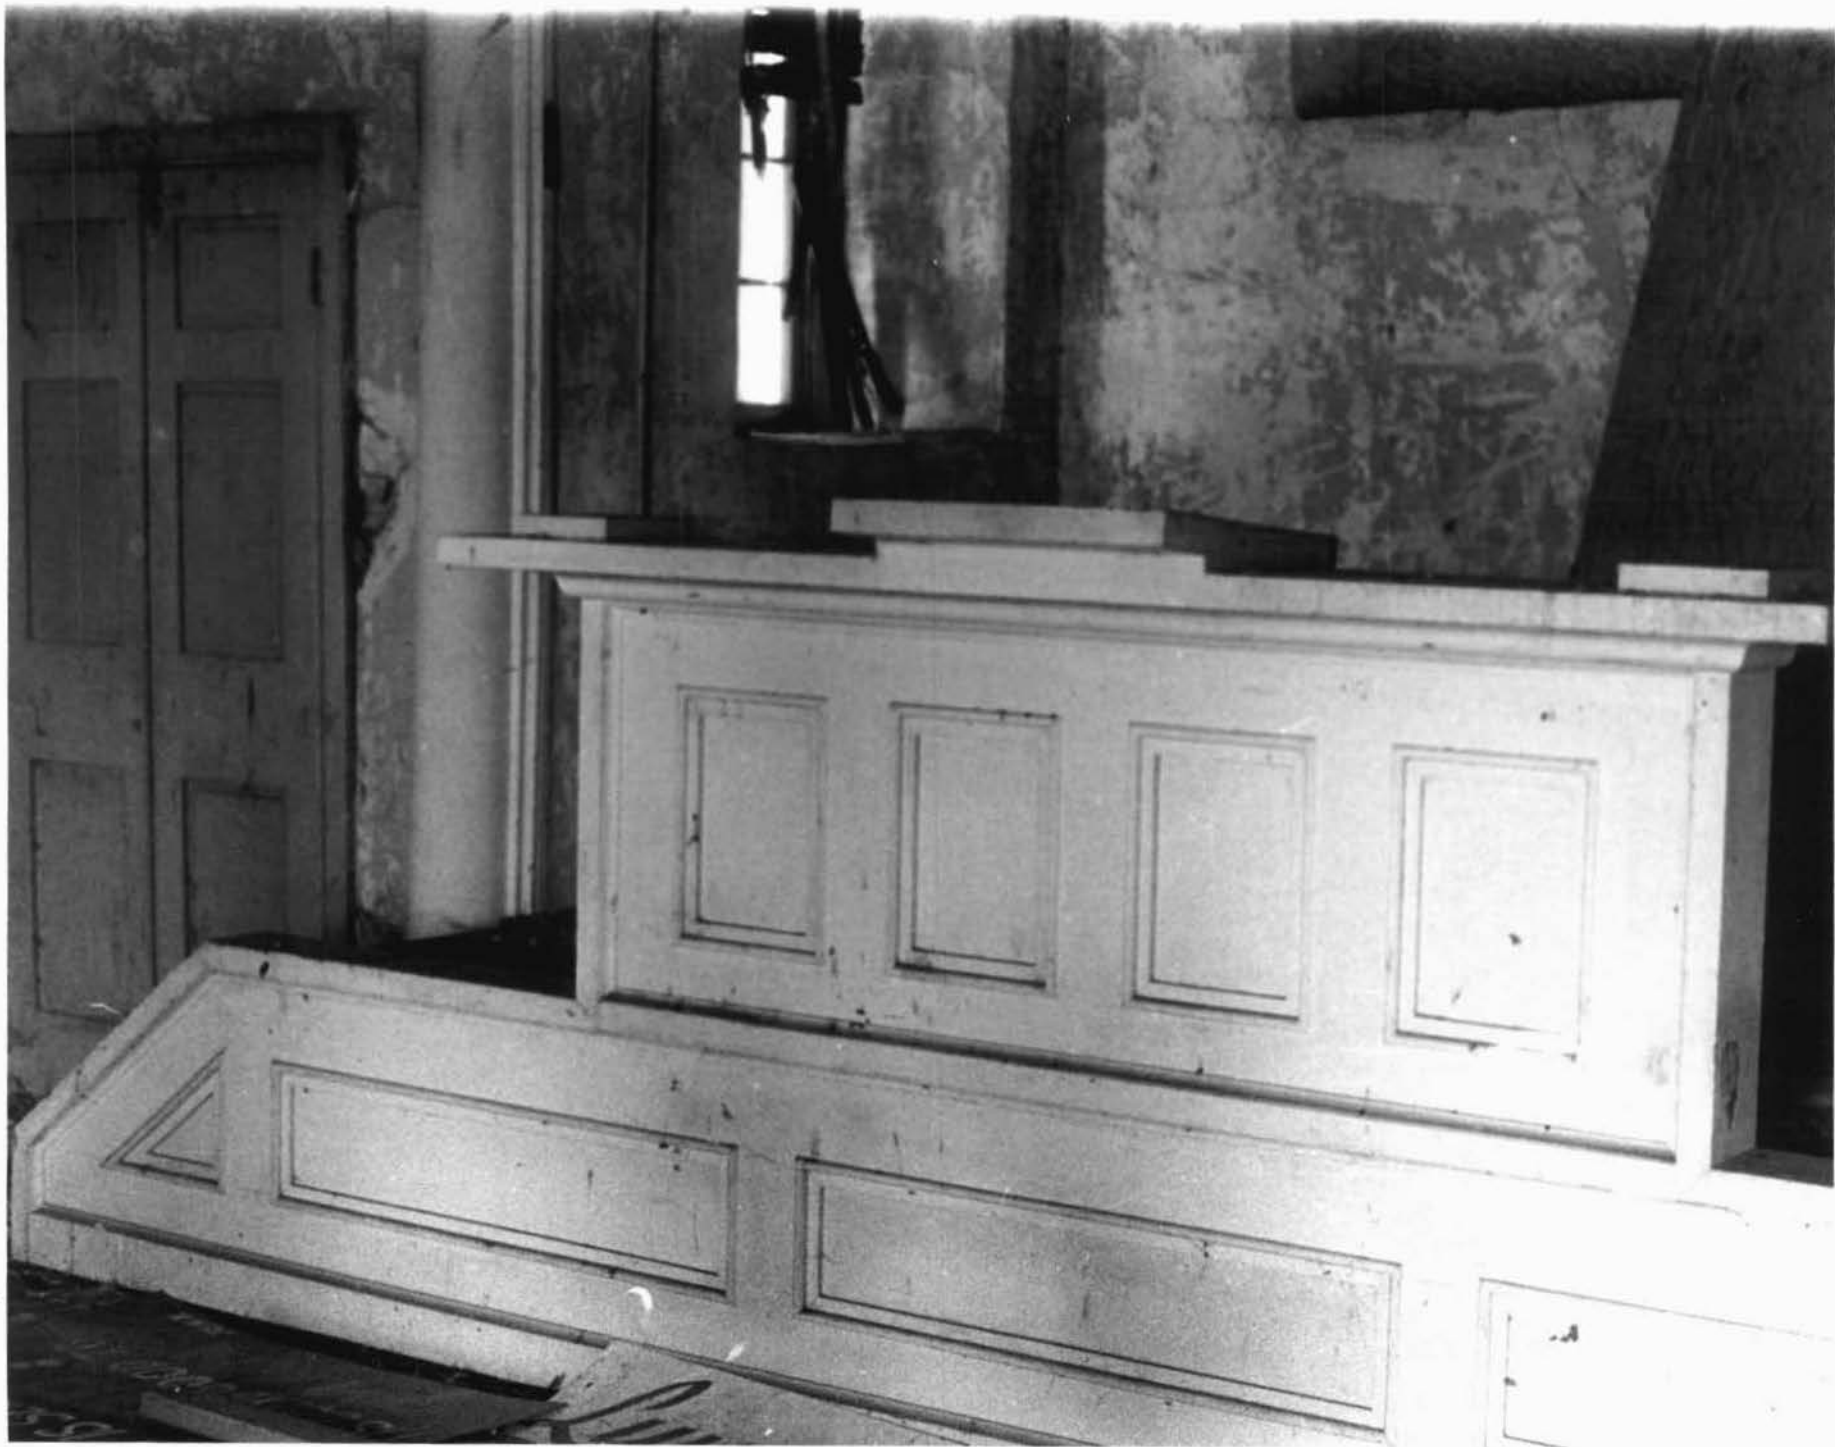
5

Interior detail - speakers podium
